# Release Note #85

**Topic:** Device Reading Disparities Pertaining to uM260-monitored Digital Panels.

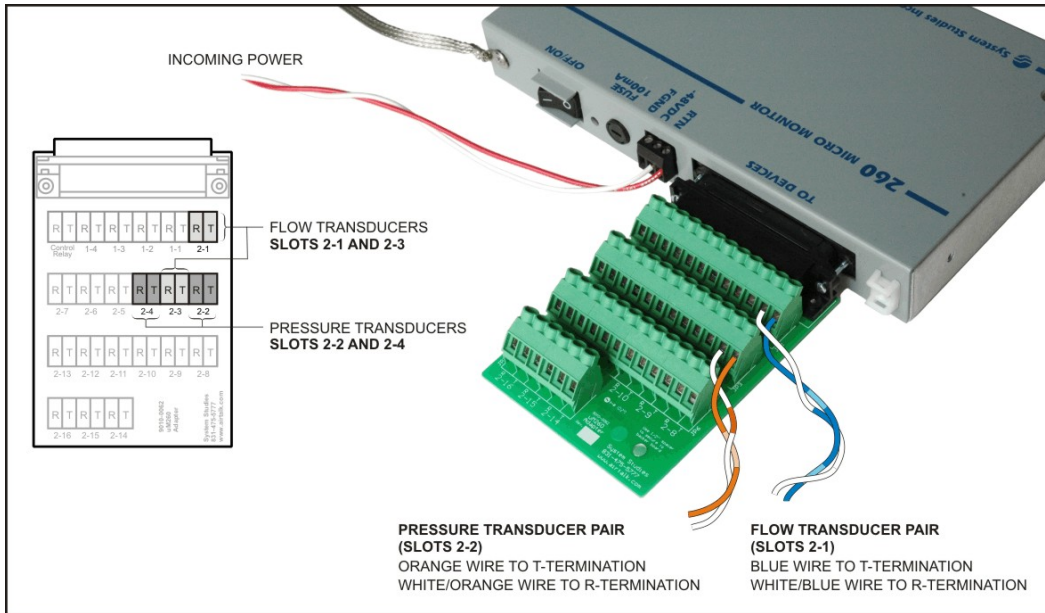
The second condition that can result in displayed digital panel output and corresponding remote device reading discrepancies is incorrect wiring at the uM260's Termination Adapter.

If you have a uM260 with firmware at or above Version 1.16 that is monitoring a digital panel and the monitor displays a reading in the negative range for a panel's pressure transducer, it is likely that the pressure and flow monitoring device pairs are transposed. For example, the pressure transducer pair (orange and white/orange conductors) may have been mistakenly punched down in the T and R slots designated as 2-1 on the Termination Adapter, and the panel's flow transducer pair (blue and white/blue) was terminated in slots 2-2.

When wiring panel High Resolution Dual Transducers on a Termination Adapter inserted into a version 1.16 or greater uM260, the flow sensor pairs (blue and white/blue) need to be terminated in the tip/ring locking jaws designated as 2-1, 2-3, 2-5, 2-7, etc. Connect the blue conductor to the T-termination and the white/blue conductor to the R-termination. The corresponding pressure sensor pairs (orange and white/orange) need to be wired to 2-2, 2-4, 2-6, 2-8, etc. Connect the orange conductor to the T-termination and the white/orange conductor to the R-termination. The image below shows the correct wiring for a digital panel's High Resolution Dual Transducer. Correcting wiring transpositions should eliminate the negative remote pressure transducer readings.
